Monitoring and evaluation of Snoqualmie Stewardship Program riparian restoration projects in the Snoqualmie Valley 2001 - 2007

Monitoring completed during Summer 2007

STEWARDSHIP PARTNERS

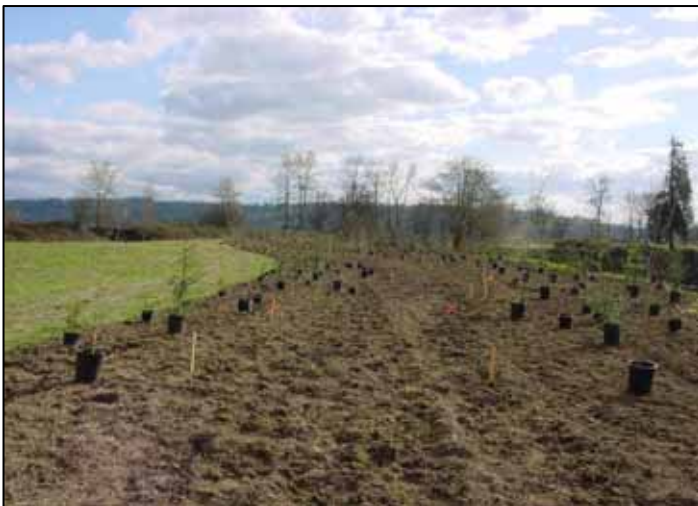
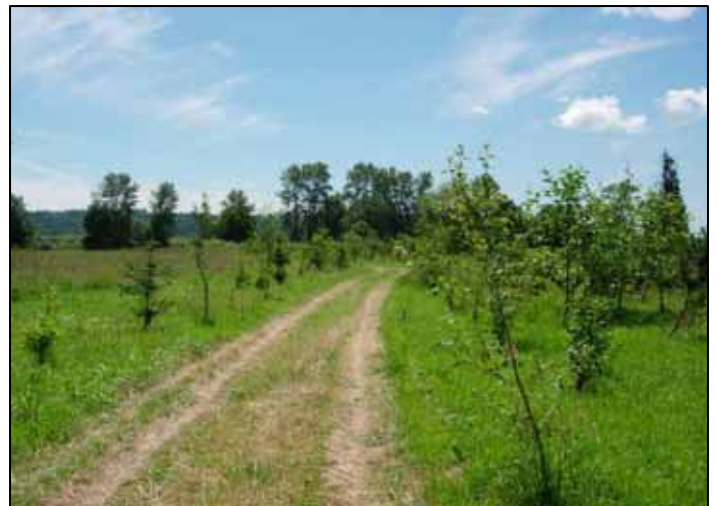
Photo-point 1 shows an overview of the northern portion of the site. Before picture (left) was taken in 2005.

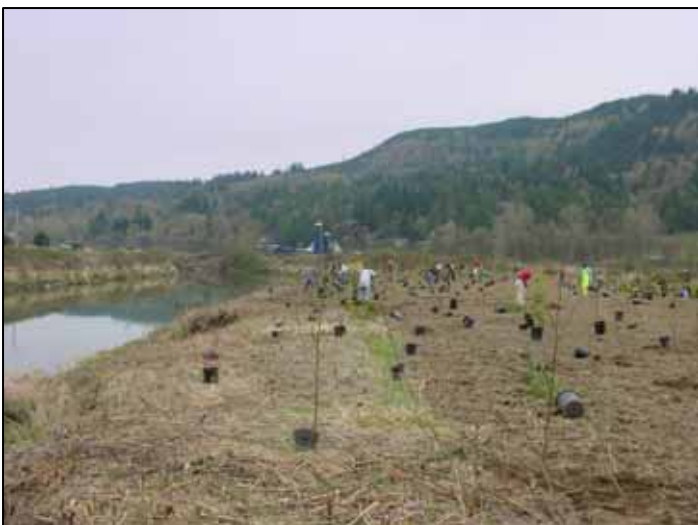
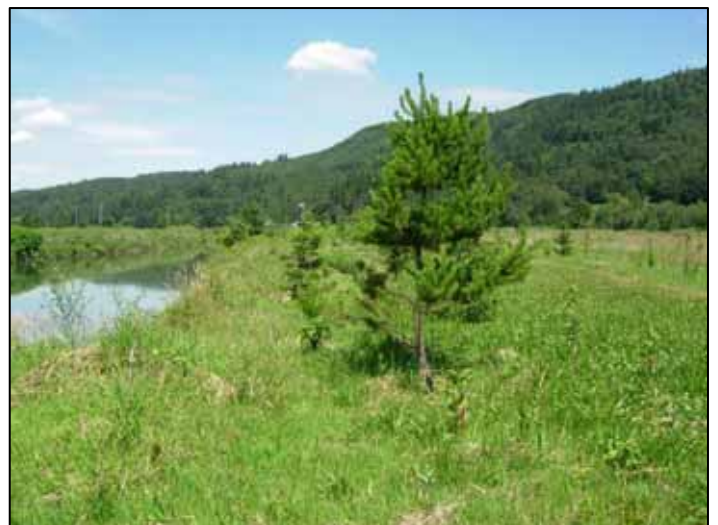
Photo-point 2 shows the northern planting area looking north.

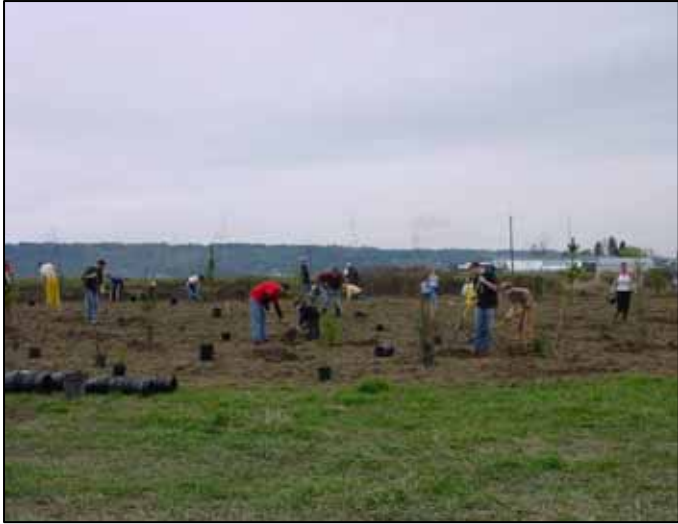
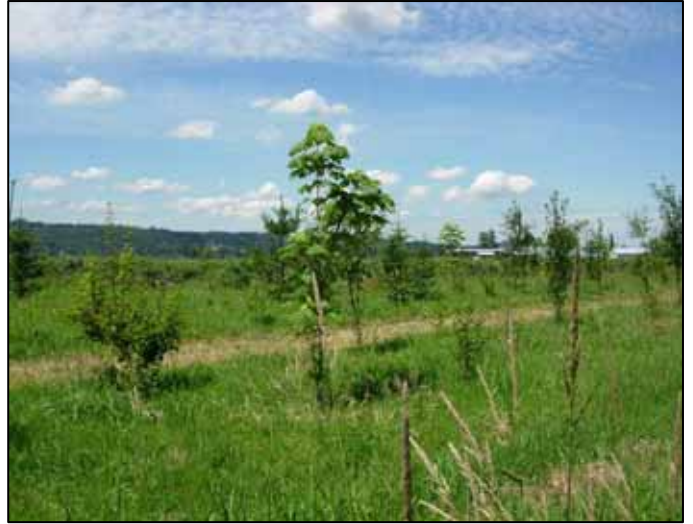
Photo-point 3 shows the northern planting area looking west towards the river.

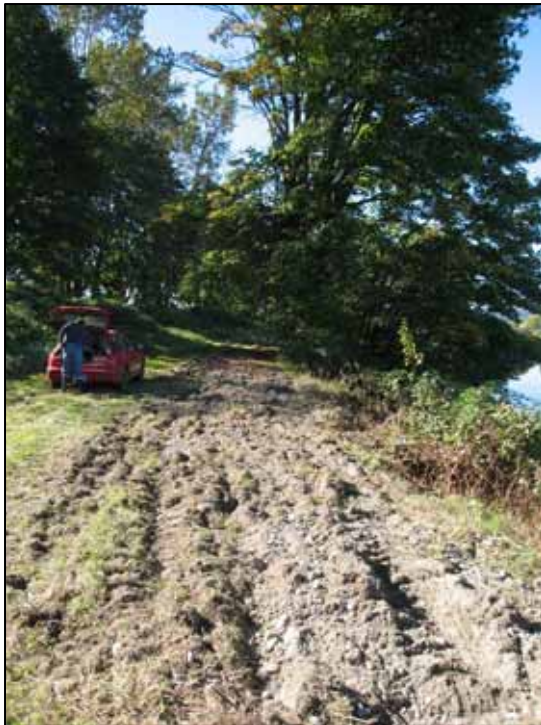
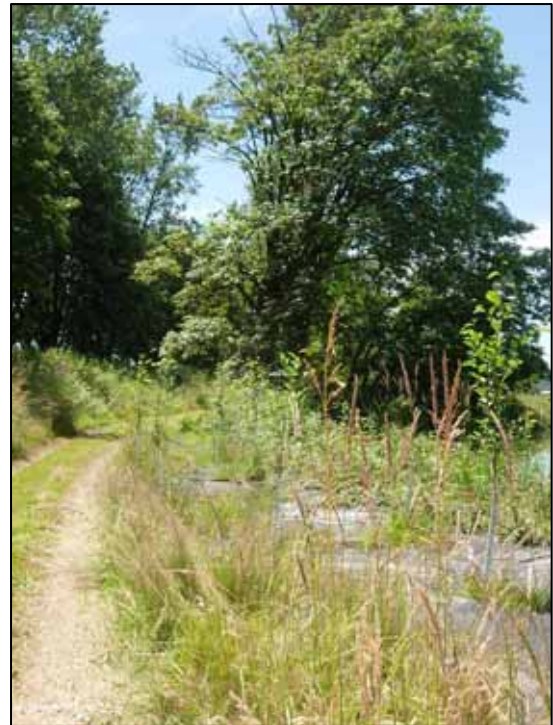
Photo-point 4 of the middle planting area. Before photo (left) was taken in October, 2006.

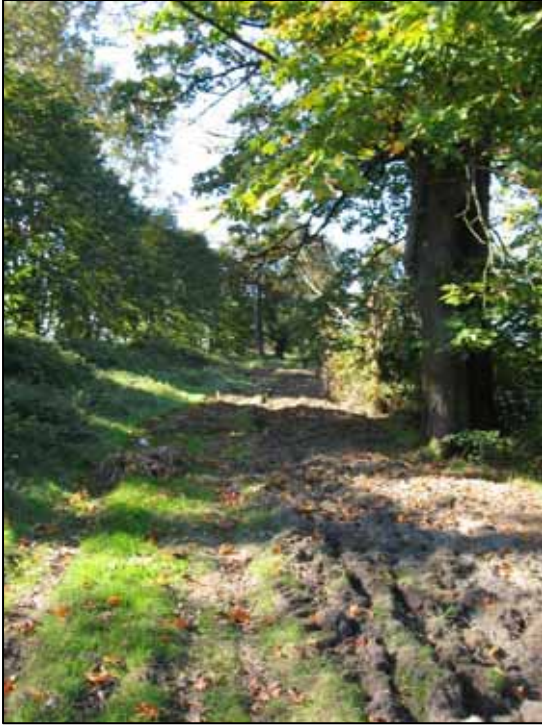
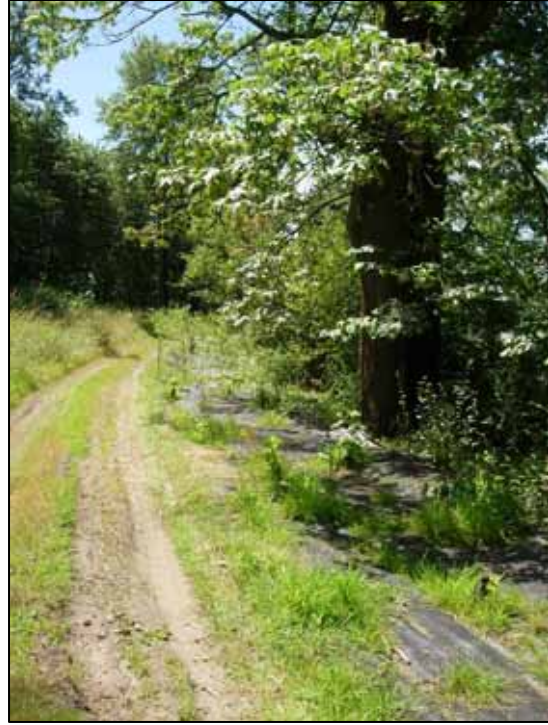
Photo-point 5 shows the middle planting area.

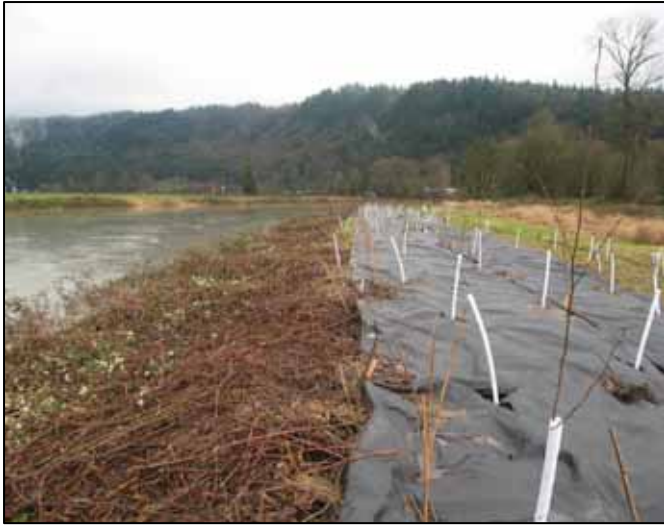
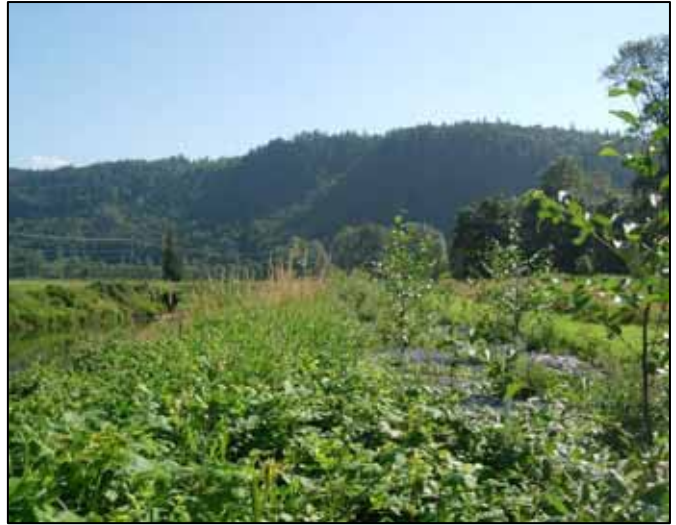
Photo-point 7 shows the southernmost planting area looking northeast

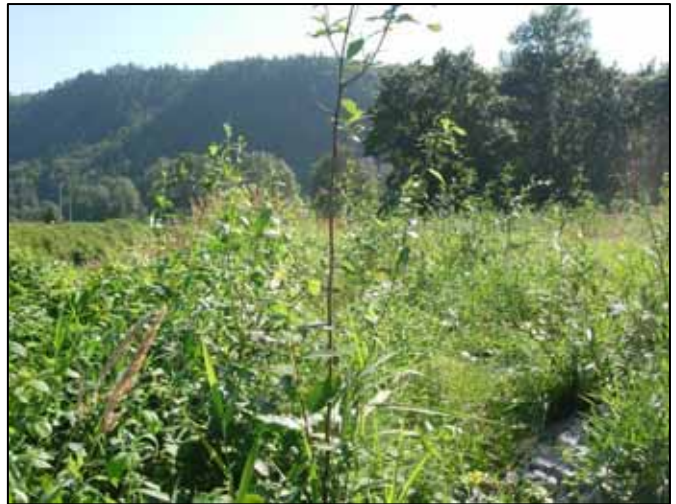
Photo-point 8 is another view of the southernmost planting

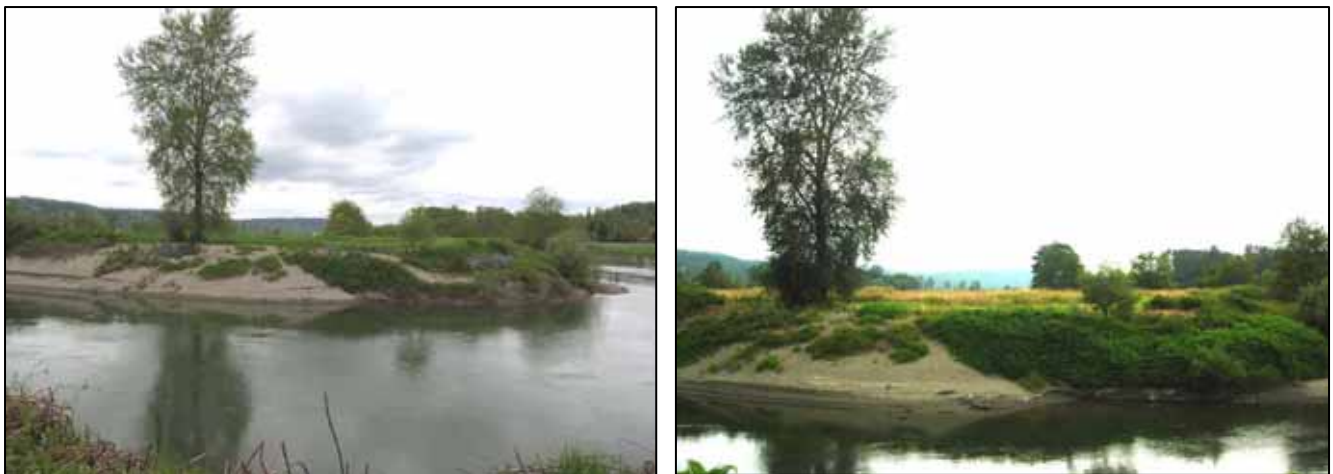
Photo-point 1 shows the Point, taken from across the river on NE 100th Street.

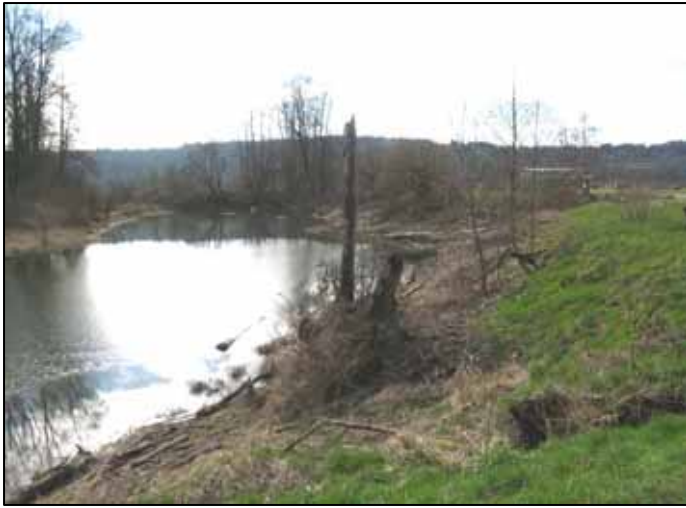
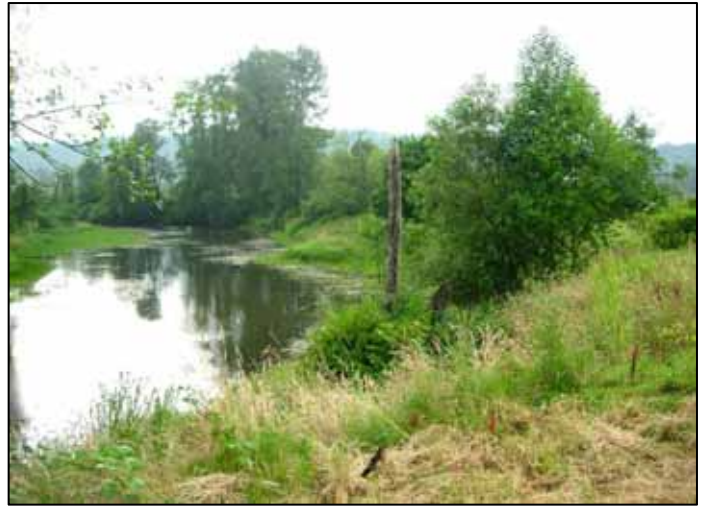
Photo-point 2 shows the planting along the oxbow pond.

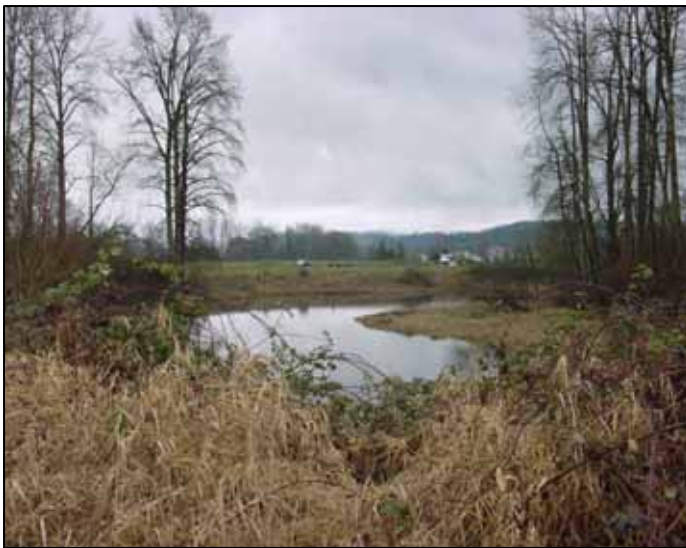
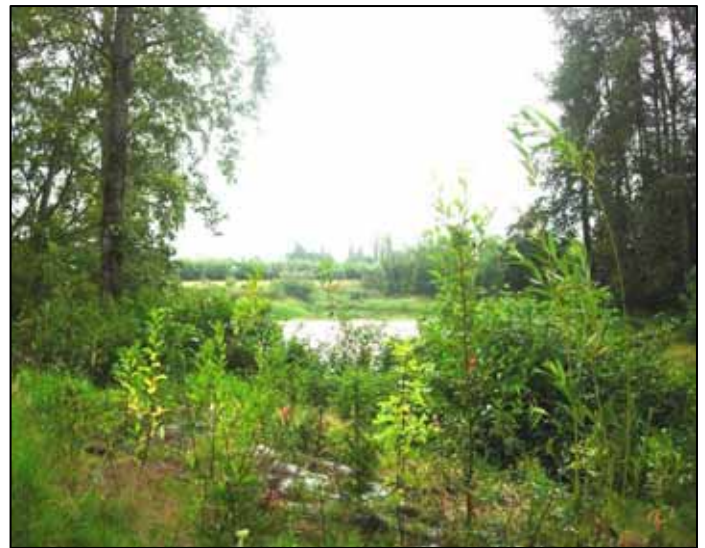
Photo-point 3 shows the planting at the bend in the oxbow pond.

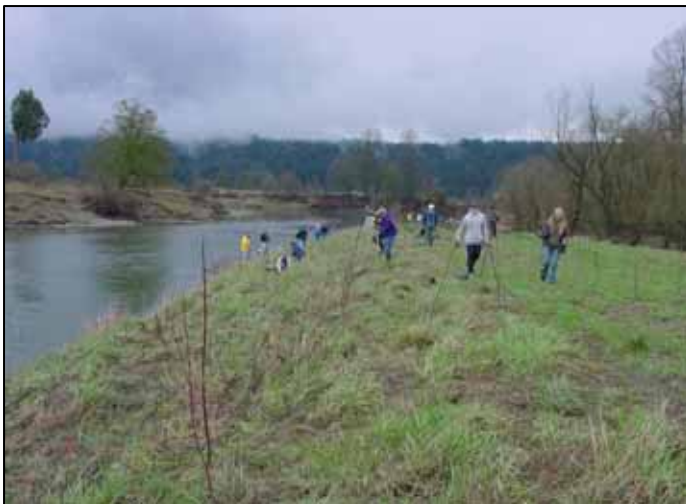
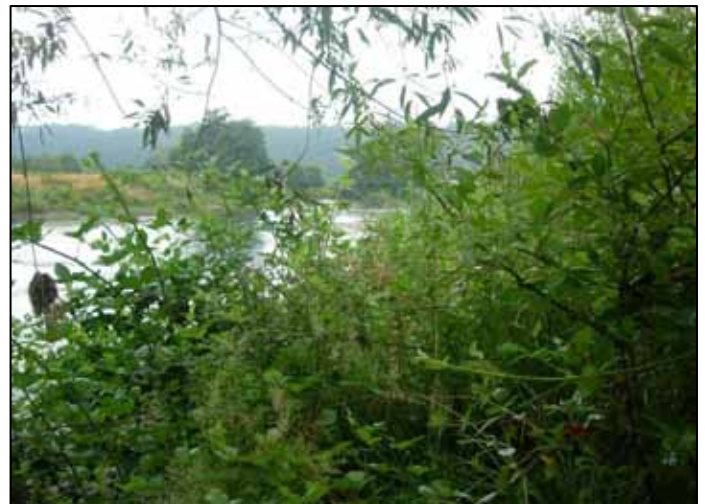
Photo-points 4, 5, and 6 show that the site has improved greatly from when it was planted in 2004 and 2006 to when the photo-points were taken in 2007. These photo-points show the alder buffer, which is the furthest upstream portion of the restoration project which is planted with primarily red alder, as well as a mixture of other species. Portions of this buffer were planted at different times, but on the whole it is doing very well. In addition to the alder, willow and other live stakes were used to stabilize the riverbank, which is a common technique that is successful once the plants become established. Photo-points 2 and 3 shows areas bordering the oxbow pond and photo-point 1 shows the Point, a sandy area that was planted in 2007. These areas are all younger and show some improvement. The Point has areas where Japanese knotweed is a problem, but it is kept in check by regular maintenance.

Photo-point 4 shows the alder buffer looking downstream.

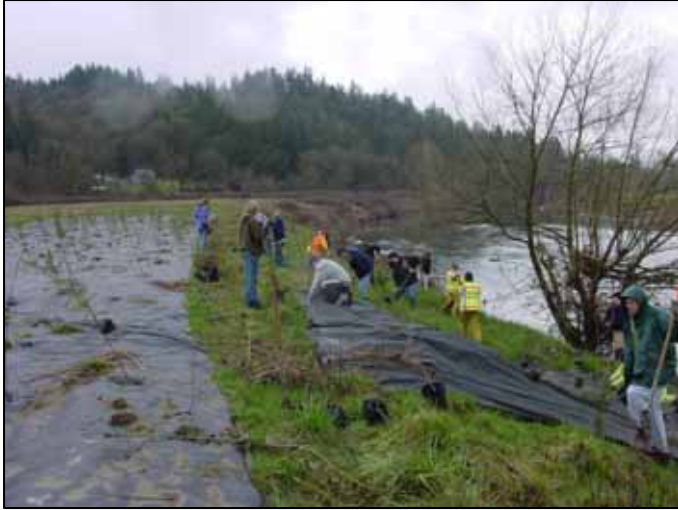
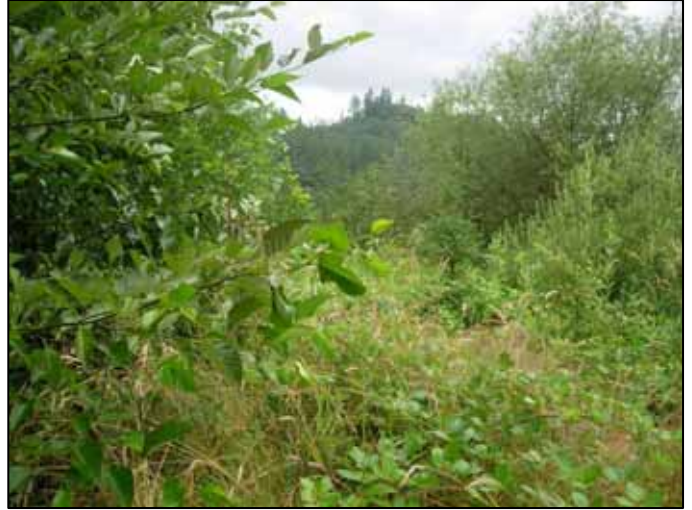
Photo-point 5 shows the alder buffer looking upstream.

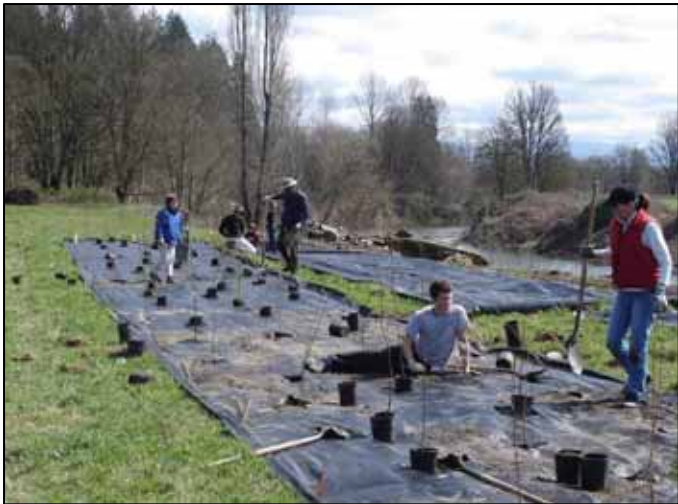
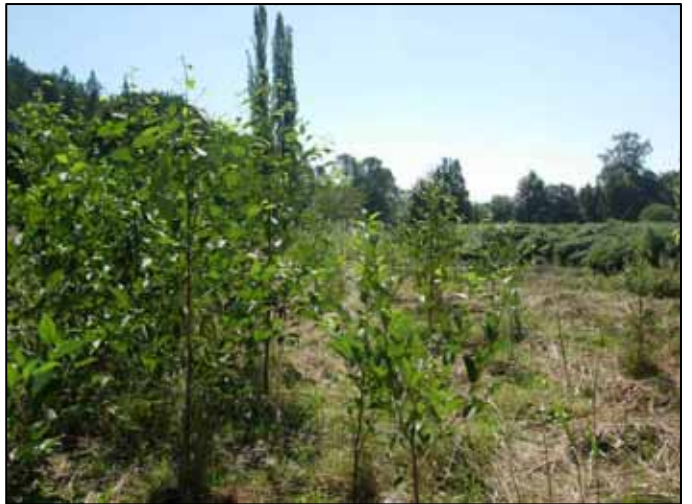
Photo-point 6 shows the southeasternmost portion of the alder buffer.

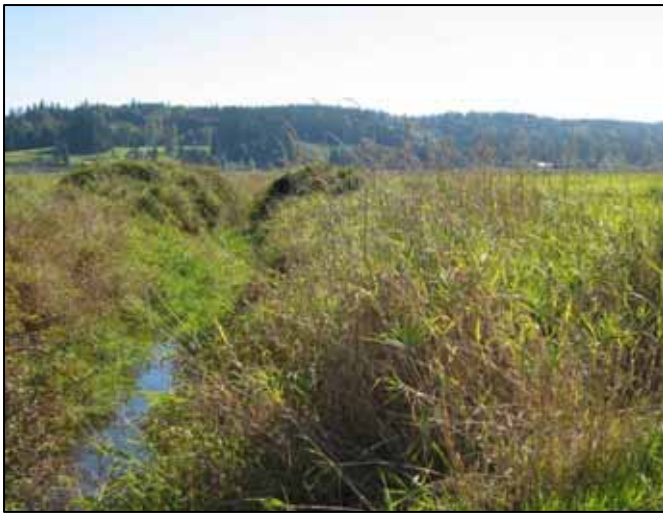
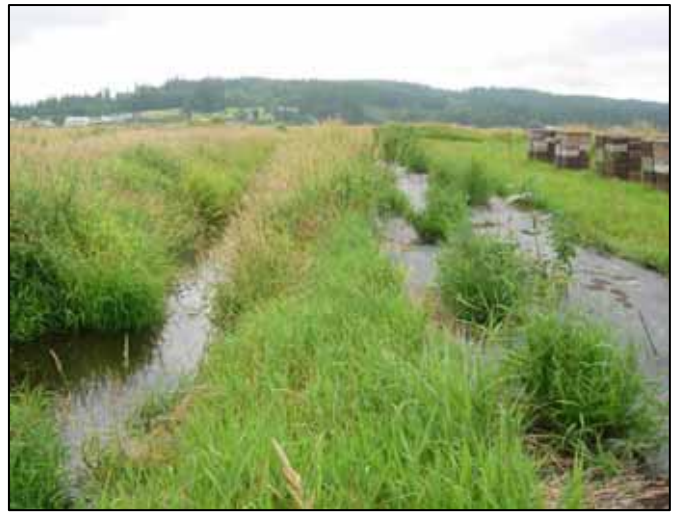
Photo-point 3 at Ames Creek Farm shows the planting area and the creek that it borders.

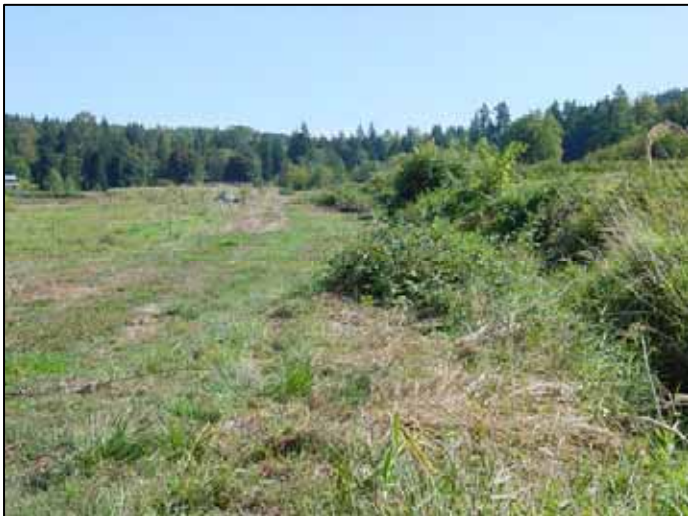
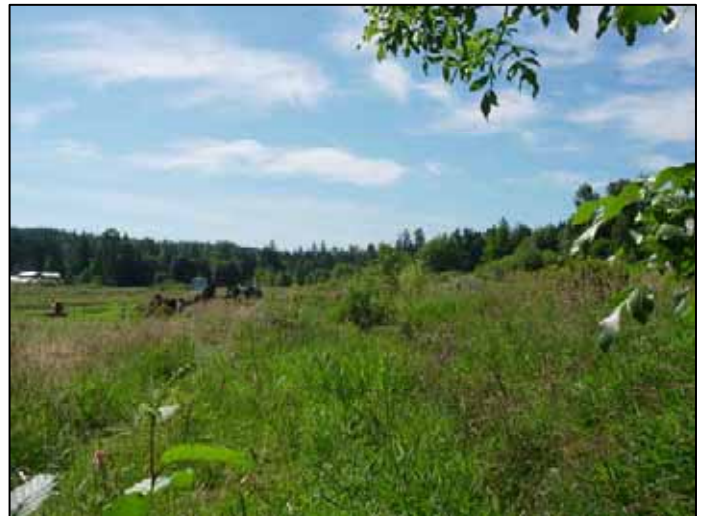
Photo-point 1 facing upstream. Before photos (left) were all taken in 2006.

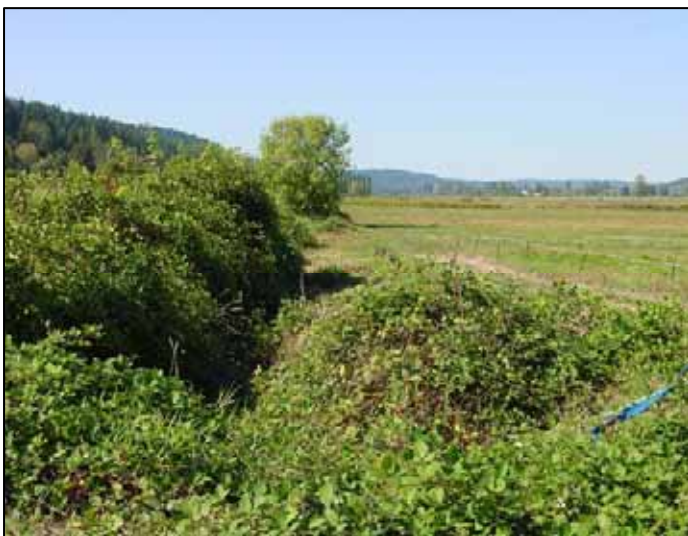
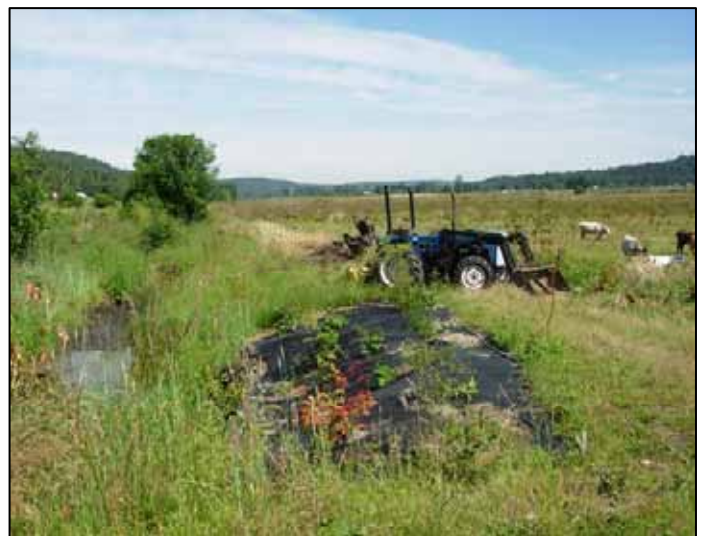
Photo-point 2 shows the site facing downstream from the culvert.

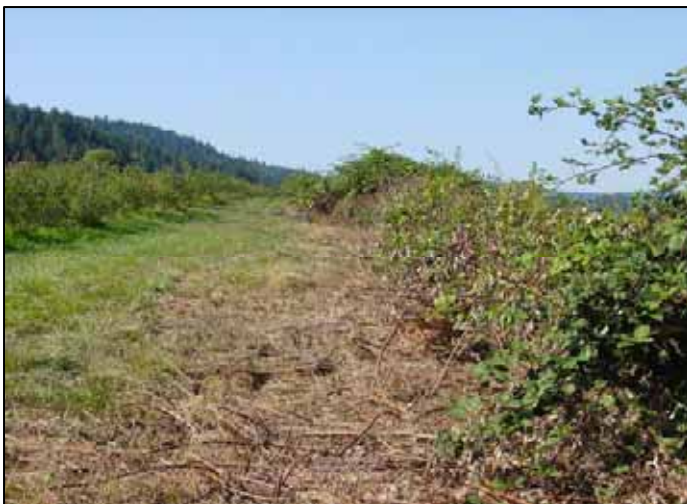
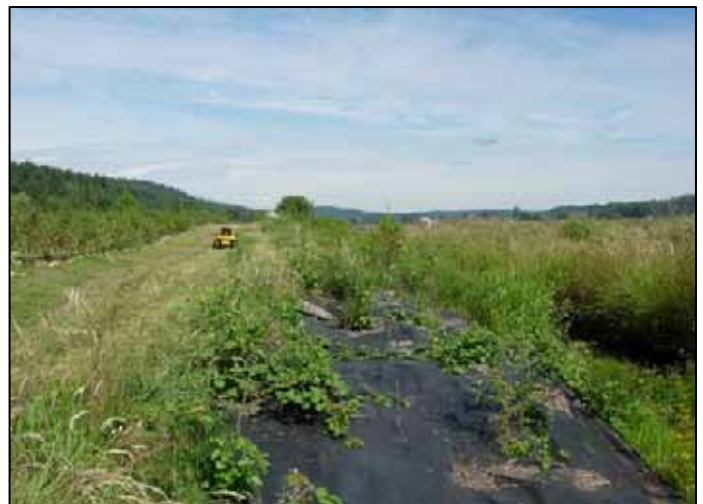
Photo-point 5 (option 2) shows the upstream portion of the site facing downstream from the fence.

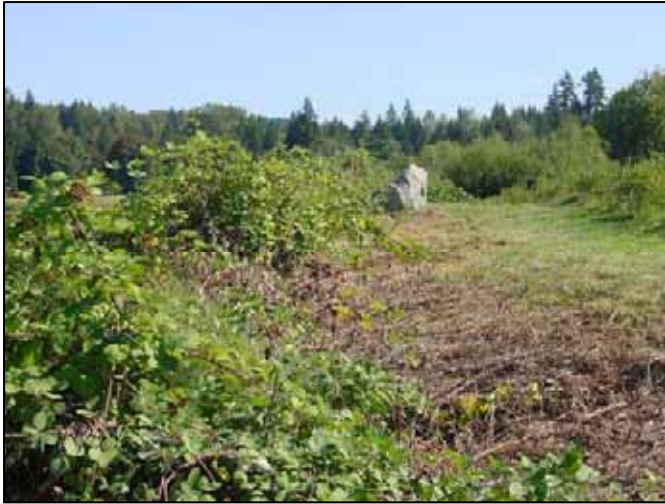
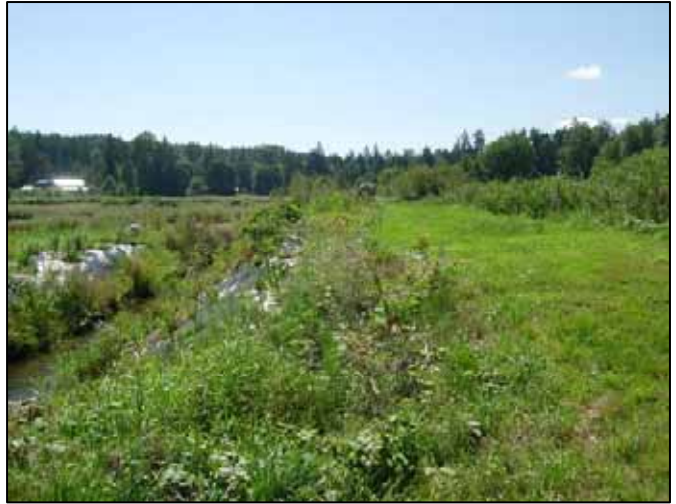
Photo-point 6 faces upstream from the culvert.

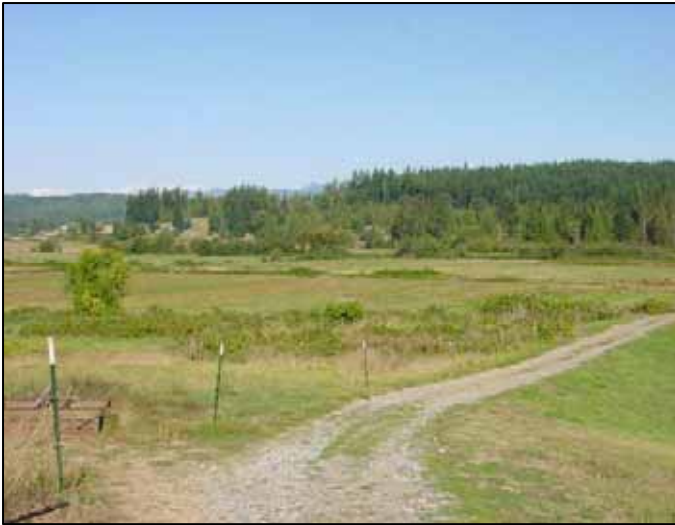
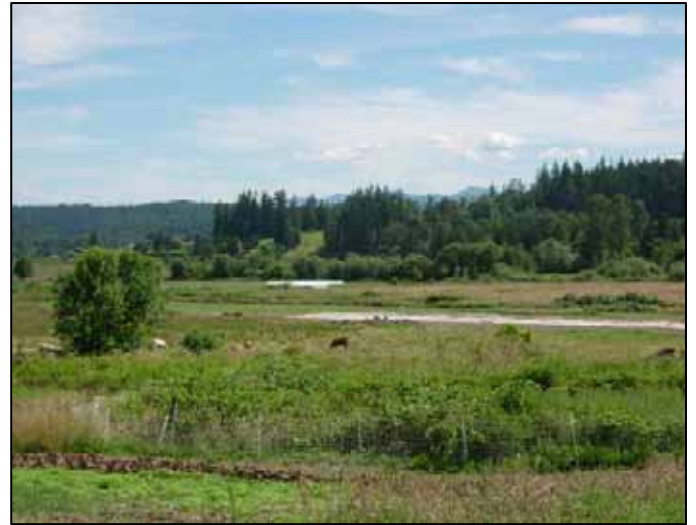
Photo-point 9 is an overview of the downstream portion of the site.

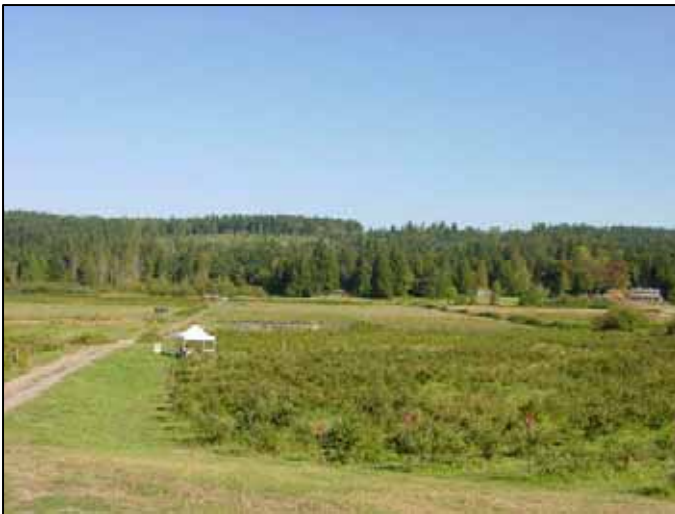
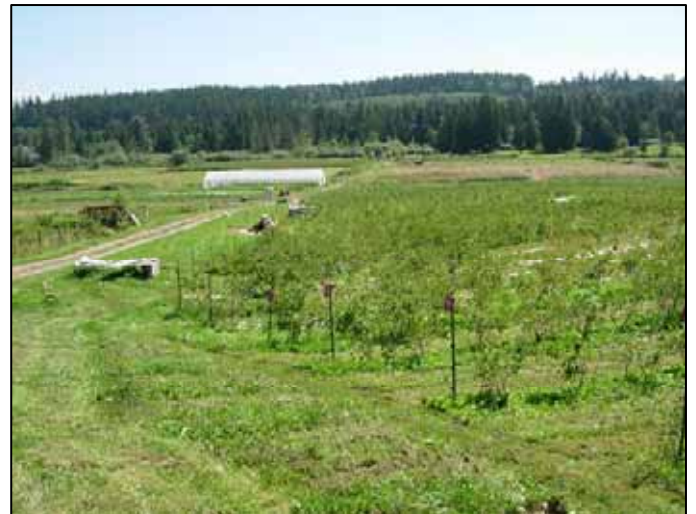
Photo-point 10 is an overview of the upstream portion of the site.

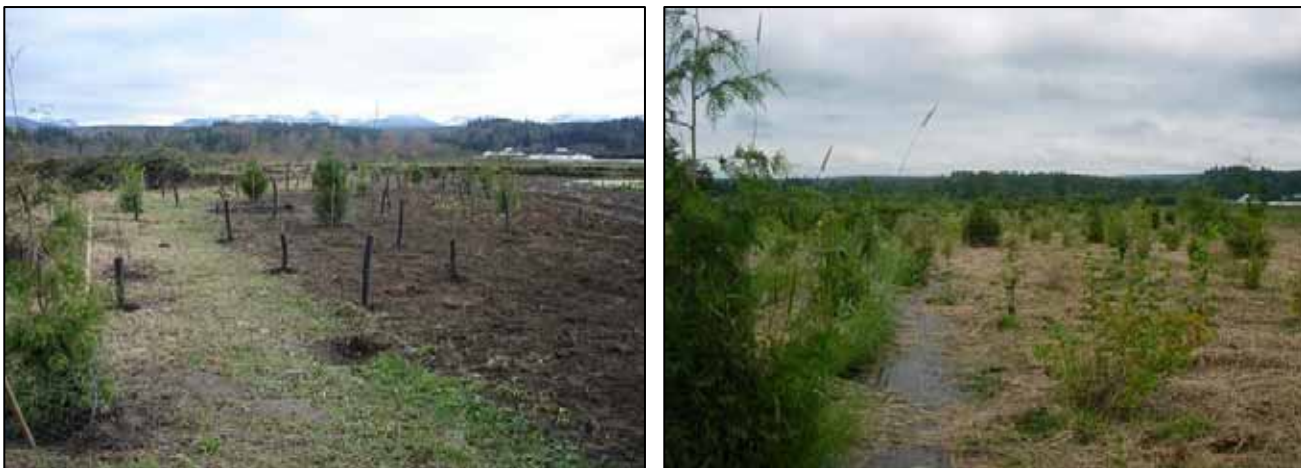
Photo-point 1 at Full Circle Farm shows the planted area facing east.

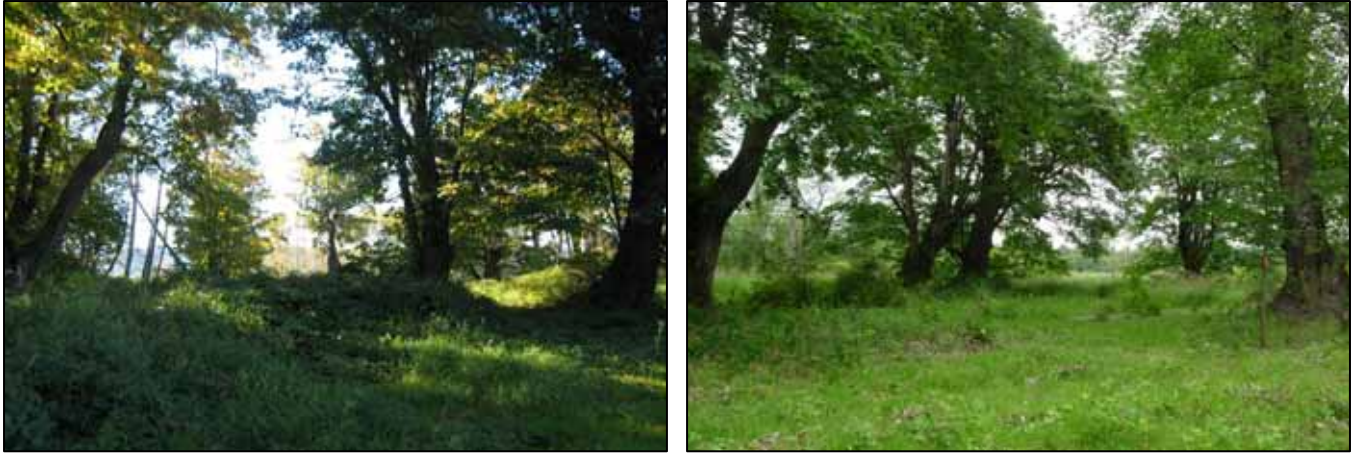
Photo-point 5 shows the forested area west of the buffer that is underplanted with trees and shrubs.

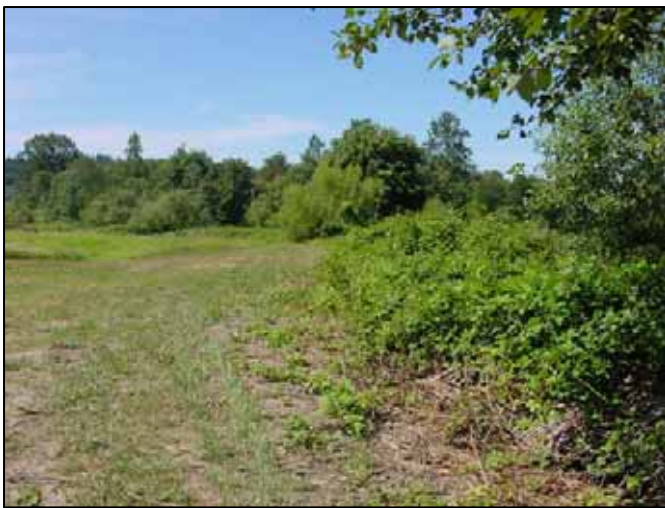
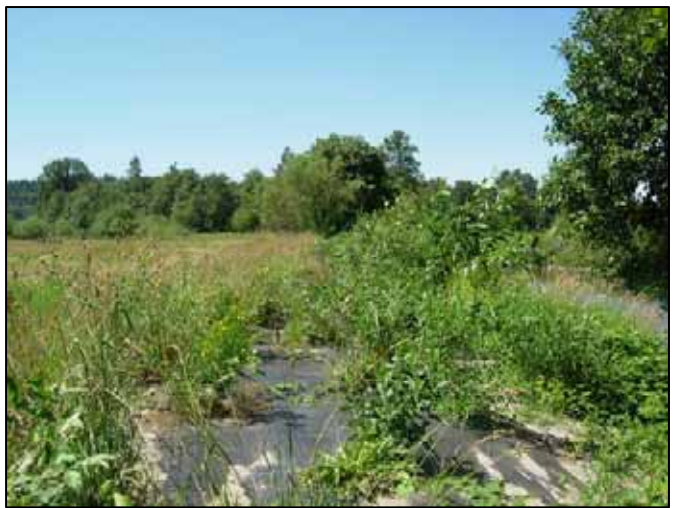
Photo-point 2 shows the buffer facing downstream from the river bend.

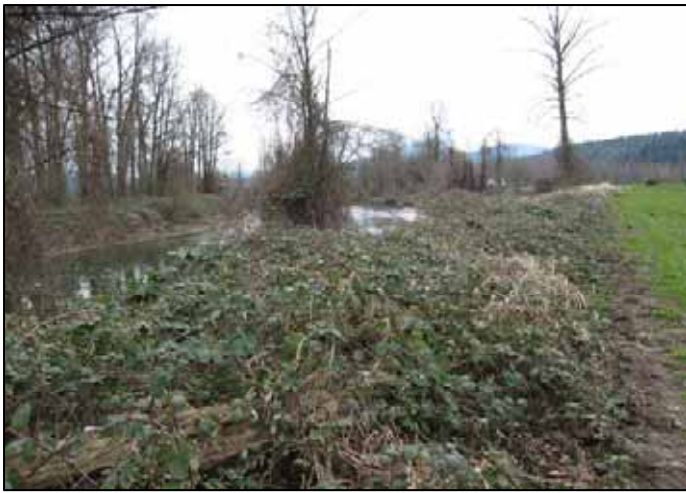
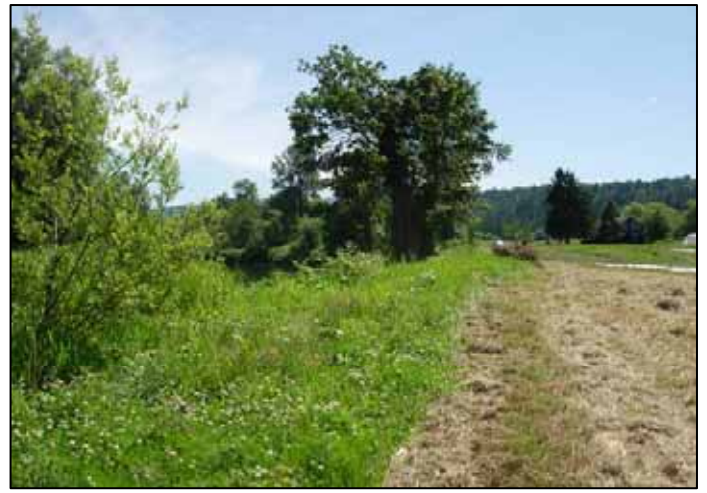
Photo-point 3 shows the buffer along the furthest upstream section of the river.

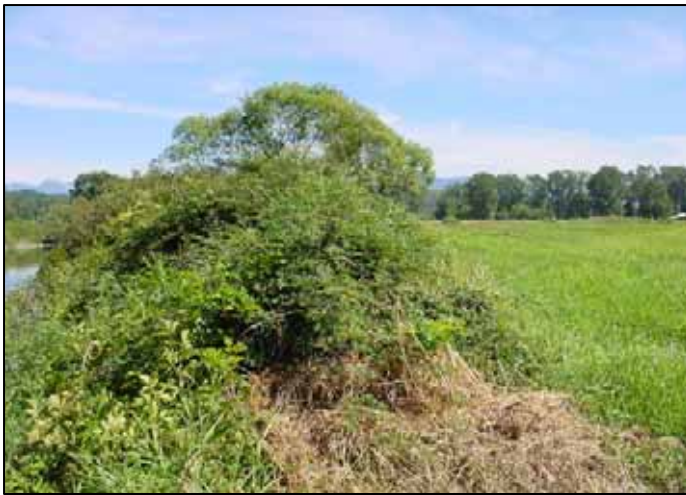
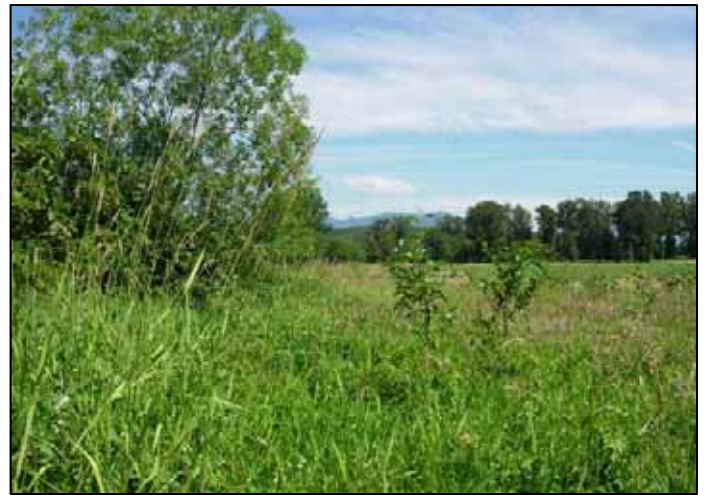
Photo-point 4 shows the buffer near the barn.

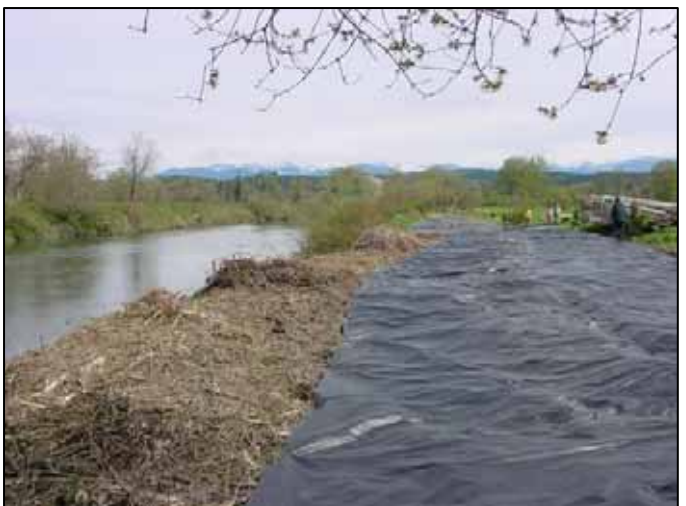
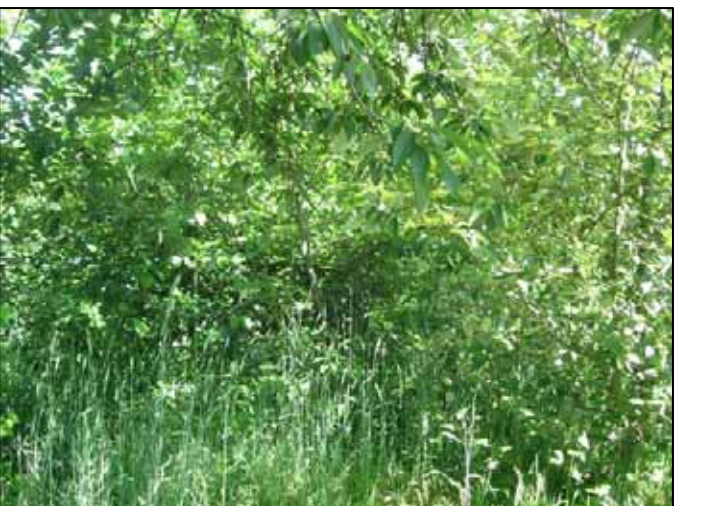
Photo-point 5 shows the downstream portion of the buffer.

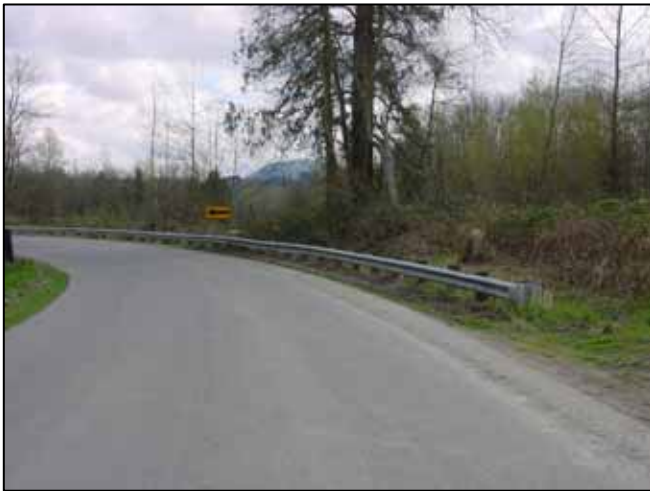
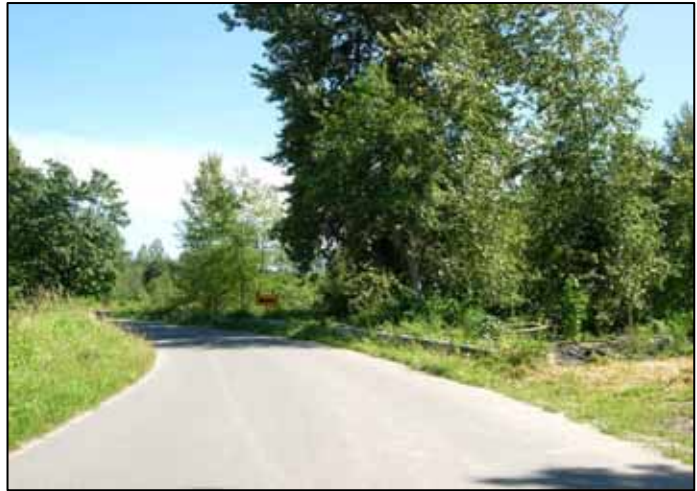
Photo-point 1 at Fall City Farms shows the planted area along the roadside.

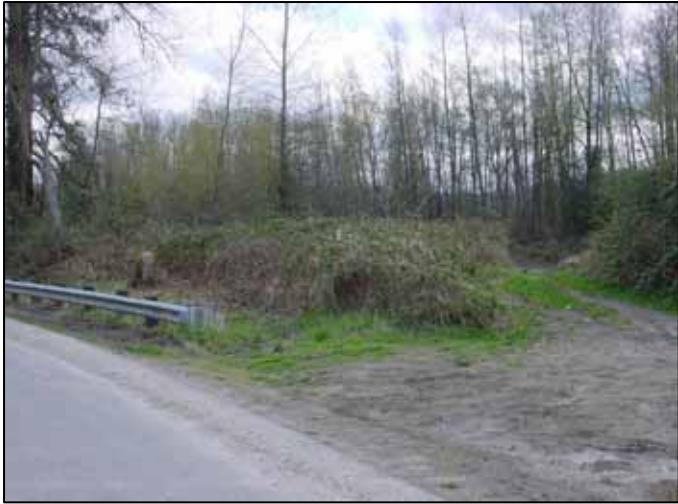
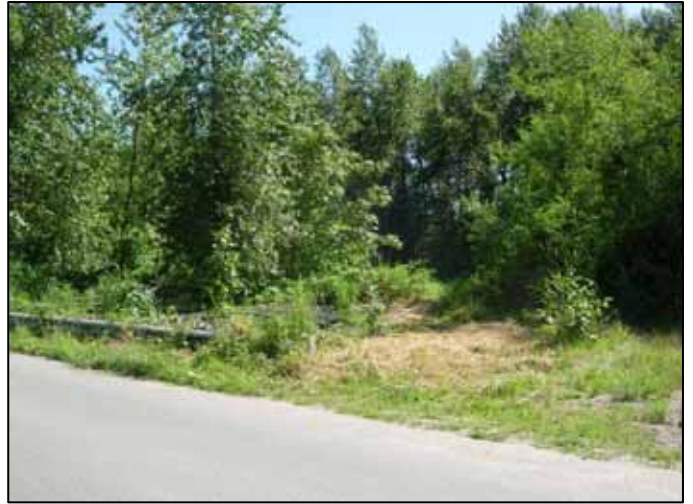
Photo-point 2 shows the planted section at the guardrail.

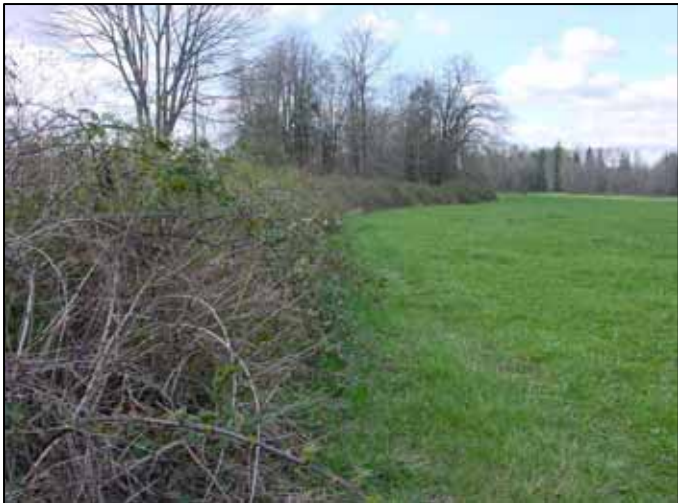
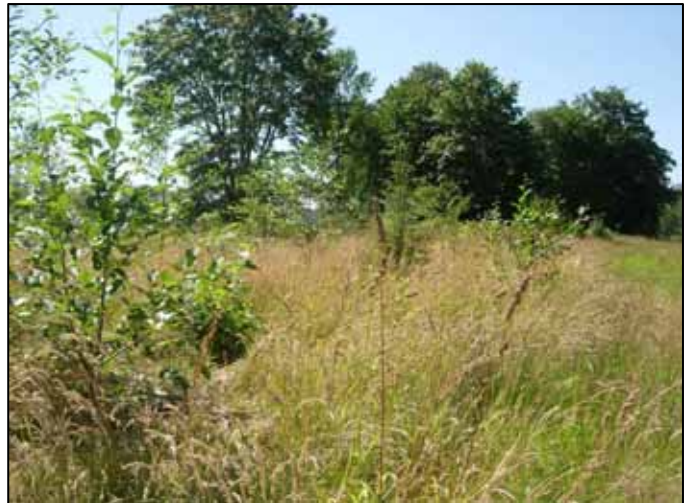
Photo-point 3 shows the planted area along the field.

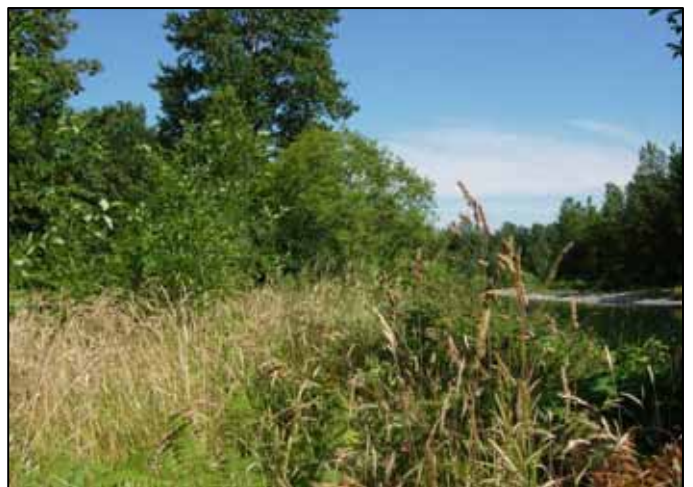
Photo-point 4 shows the planted area along the field looking the opposite direction from photo-point 3.

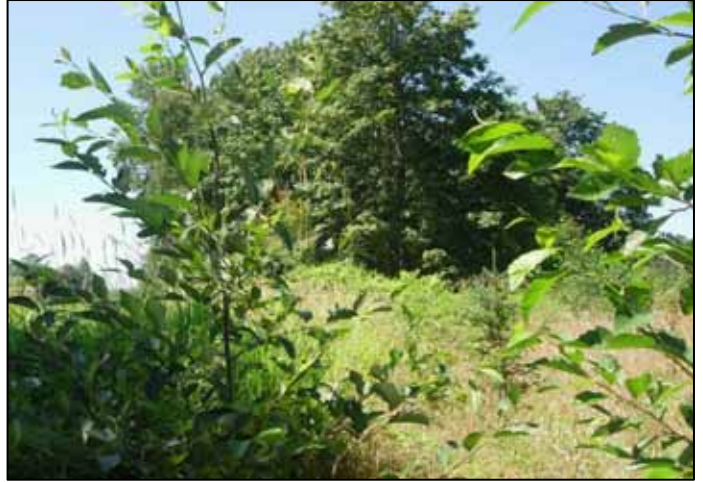
Photo-point 5 is taken from within the planted area.

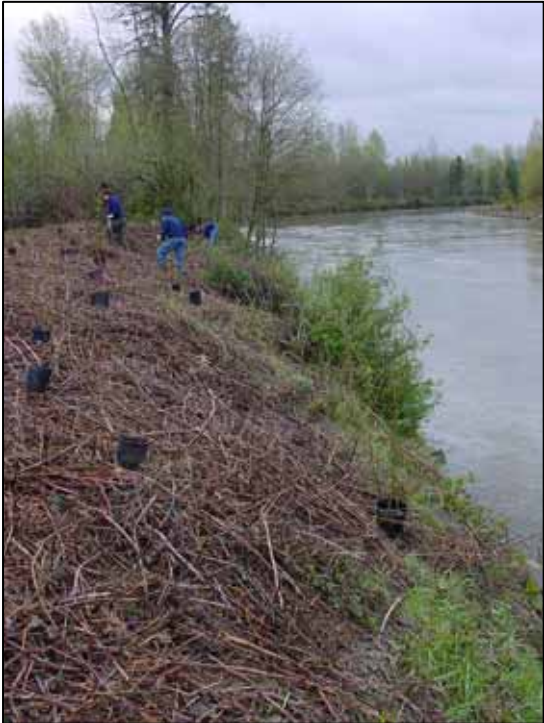
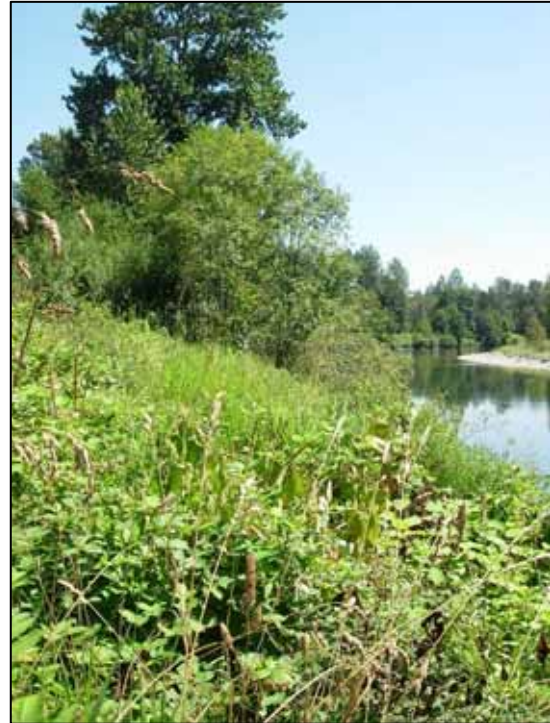
Photo-point 6 shows plantings on the slope of the riverbank.

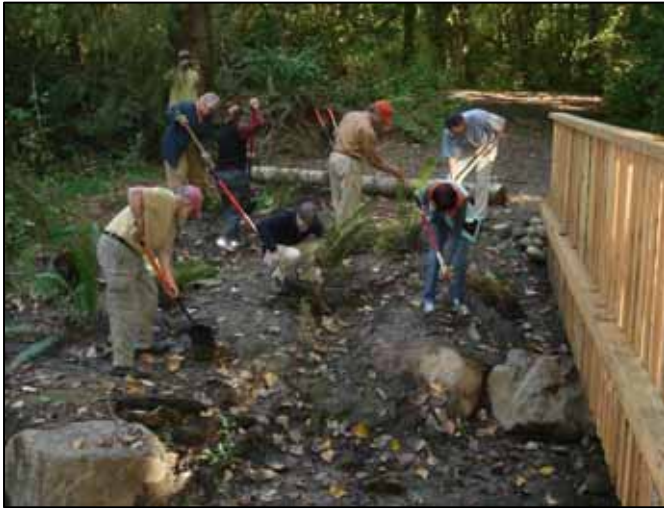
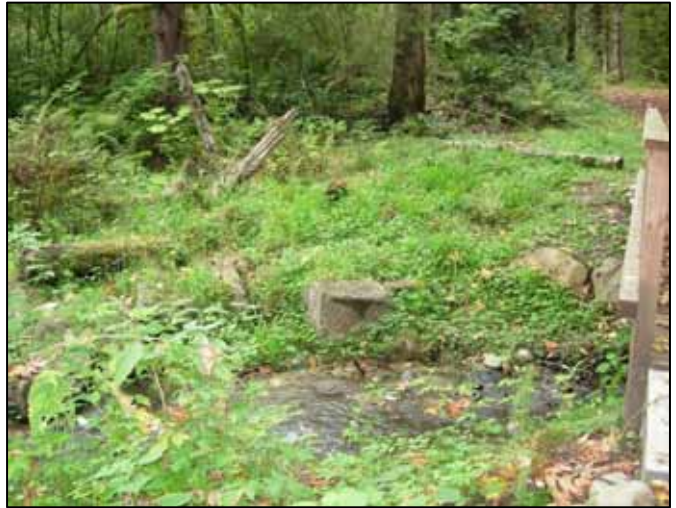
Photo-point 1 shows the upstream portion of the restoration site, while being planted in 2006 (left), and in 2007 (right).
