Monitoring and evaluation of Snoqualmie Stewardship Program riparian restoration projects in the Snoqualmie Valley 2001 - 2007

Monitoring completed during Summer 2007

STEWARDSHIP PARTNERS

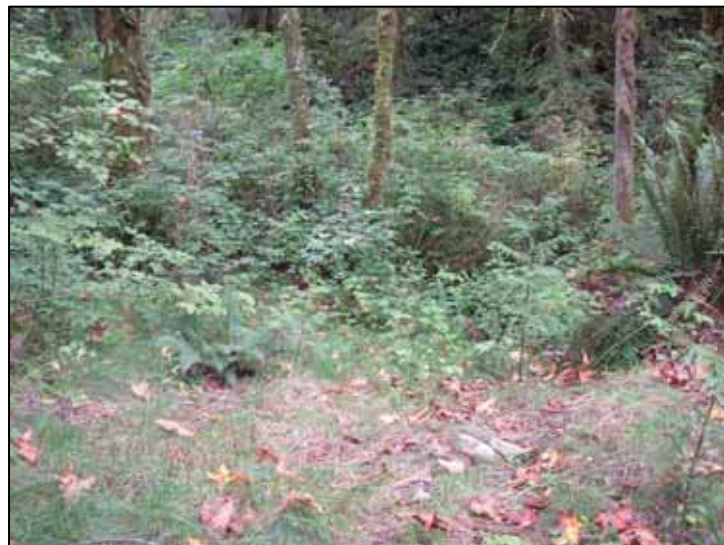
Photo-point 2 shows the downstream portion of the site in 2007. There is no corresponding ‘before’ picture for this area.

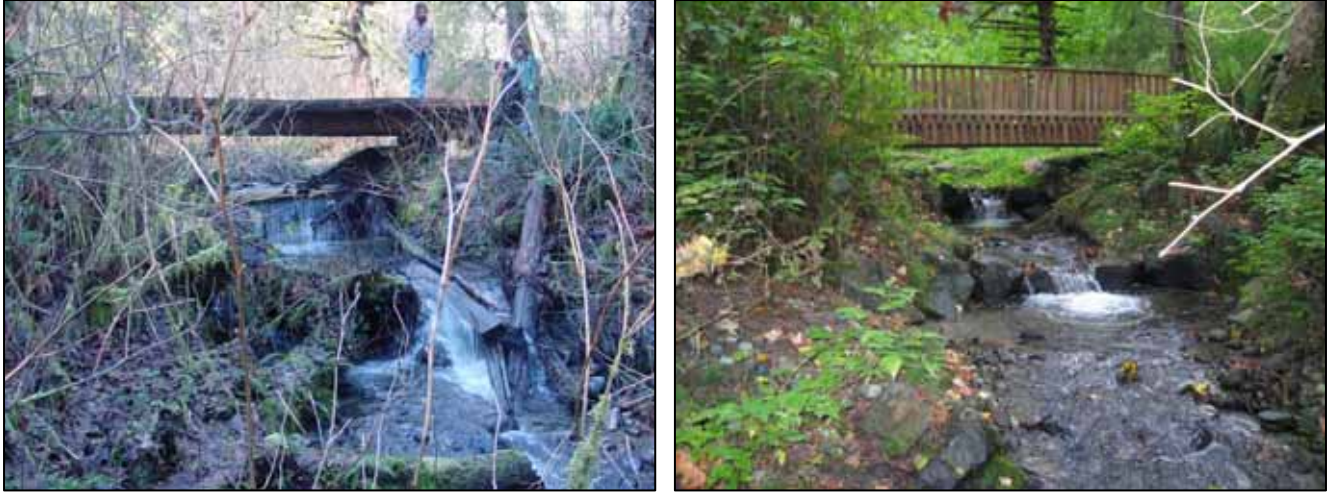
Photo-point 3 shows the fish passage aspect of this project, in the decreased gradient of the stream from before the project (left) to after (right).
