Monitoring and evaluation of Snoqualmie Stewardship Program riparian restoration projects in the Snoqualmie Valley 2001 - 2007

Monitoring completed during Summer 2007

STEWARDSHIP PARTNERS

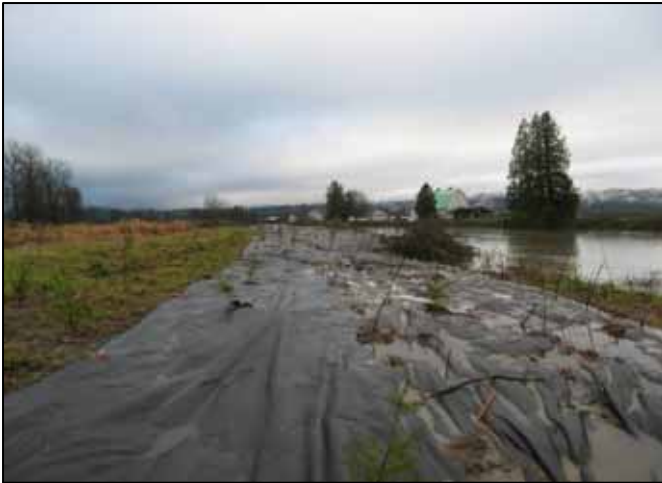
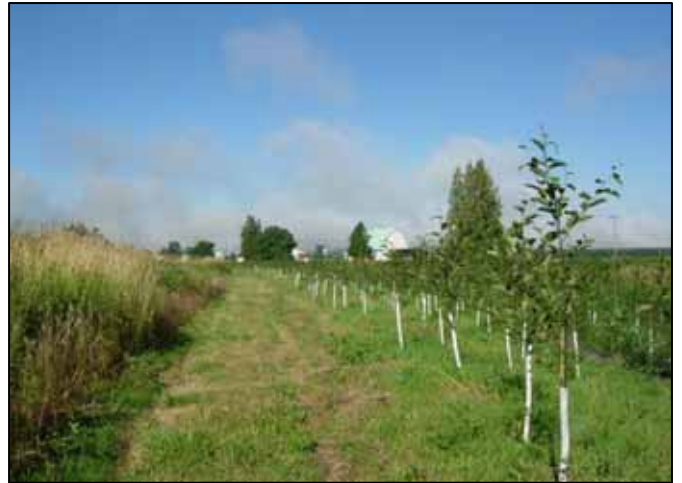
Photo-point 6 shows the southernmost planting

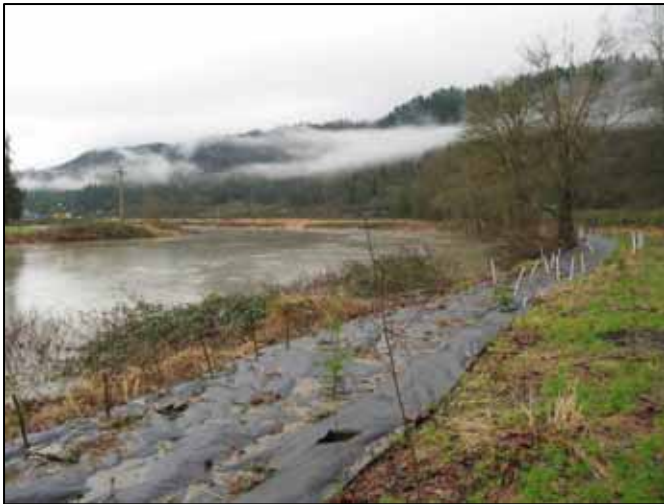
Photo-point 8 is another view of the southernmost planting

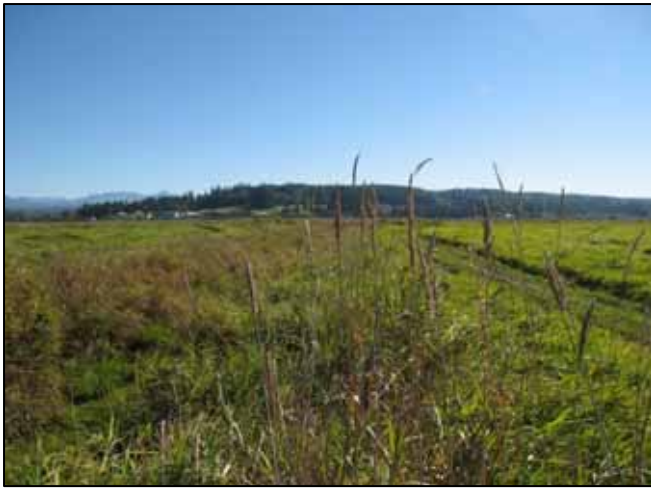
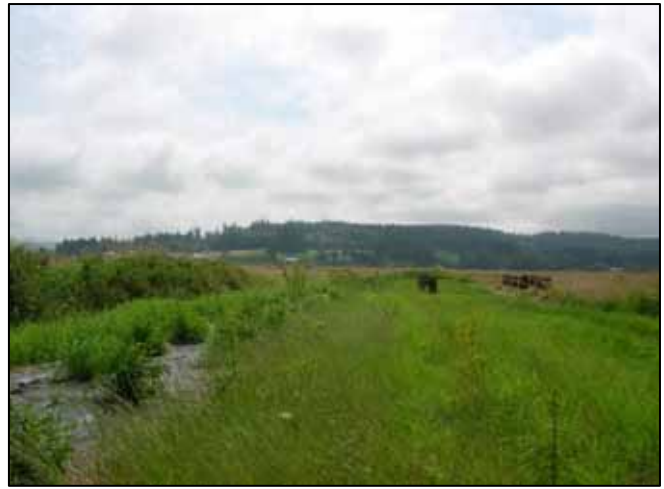
Photo-point 1 at Ames Creek Farm shows the planting area facing east.

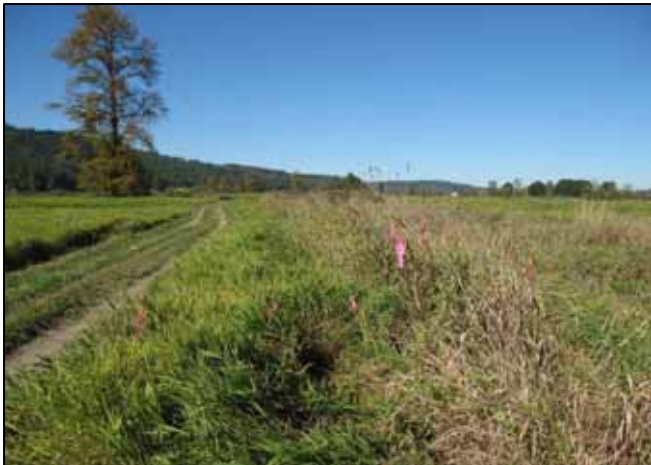
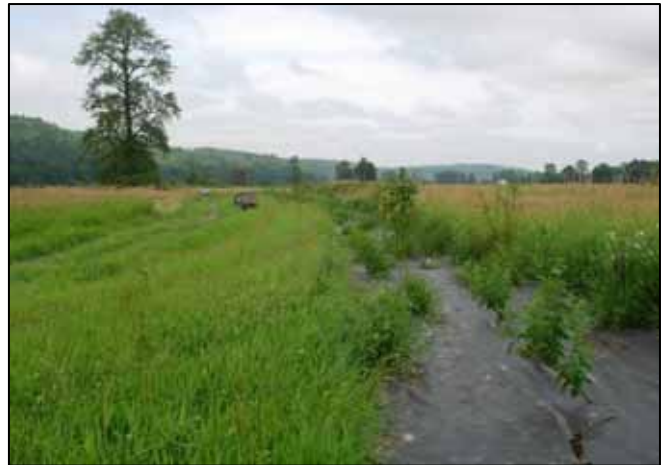
Photo-point 2 at Ames Creek Farm shows the planting area facing west.

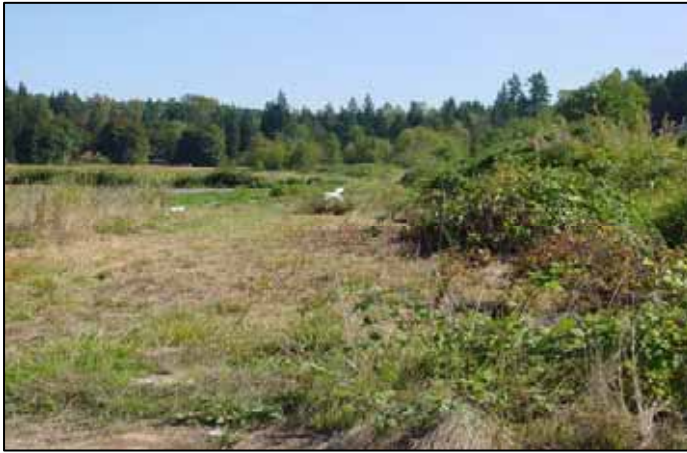
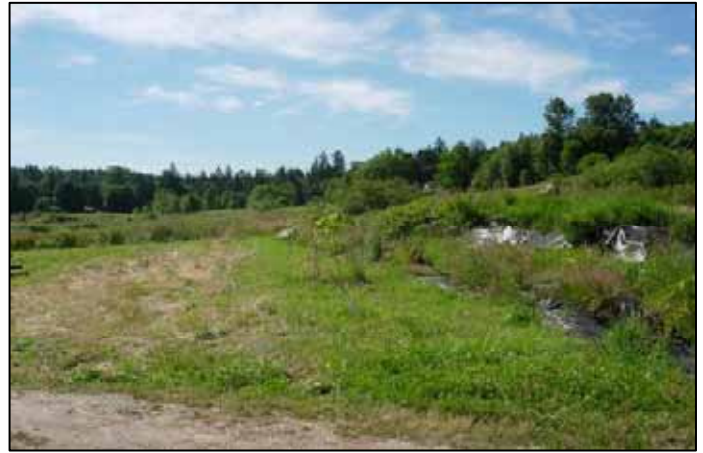
Photo-point 3 shows the site facing upstream from the culvert.

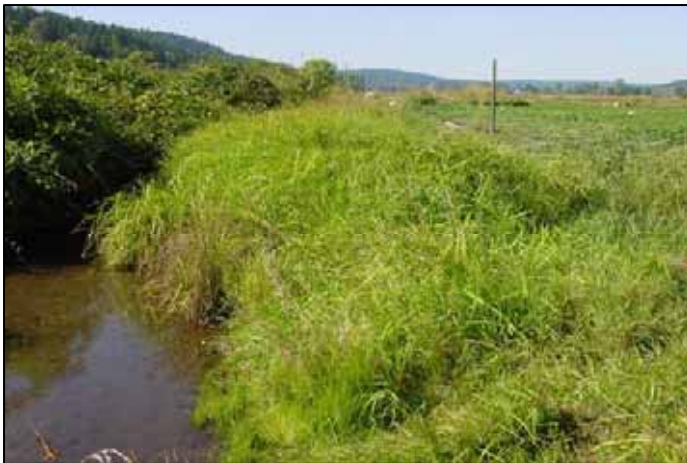
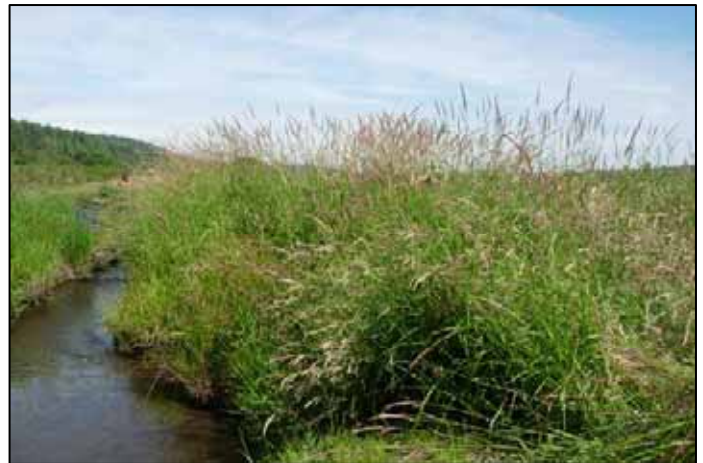
Photo-point 4 shows the upstream portion of the site, looking downstream from the fence.

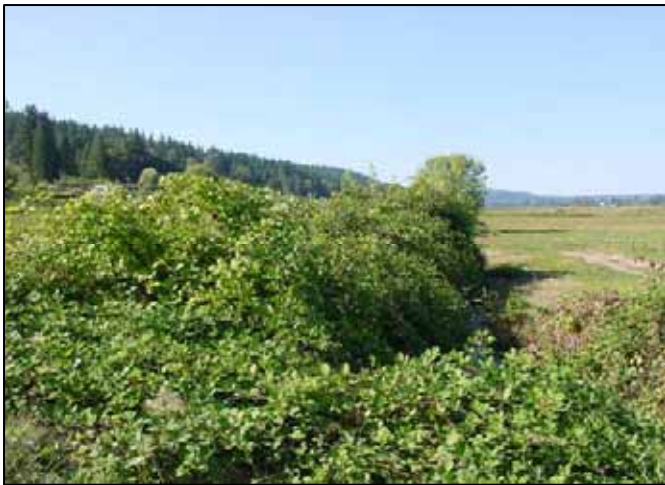
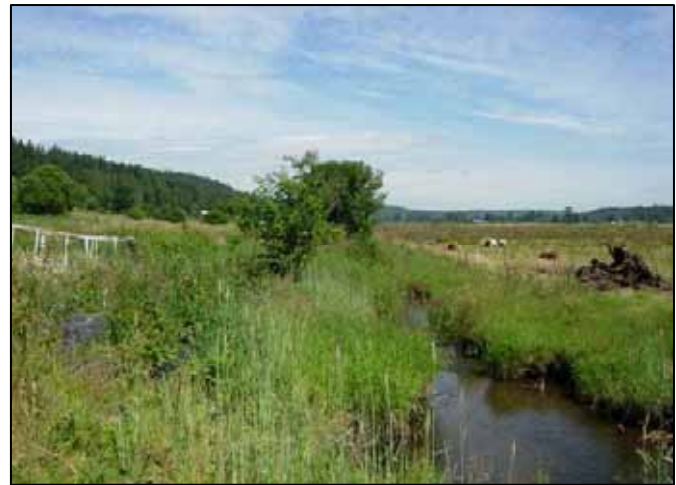
Photo-point 7 shows the site facing downstream from the culvert.

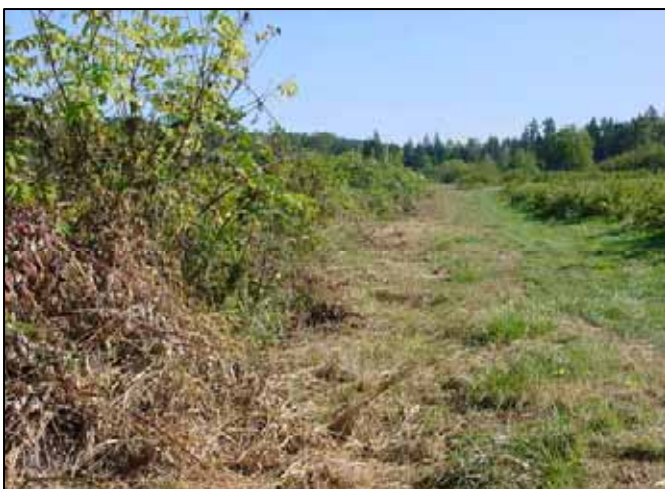
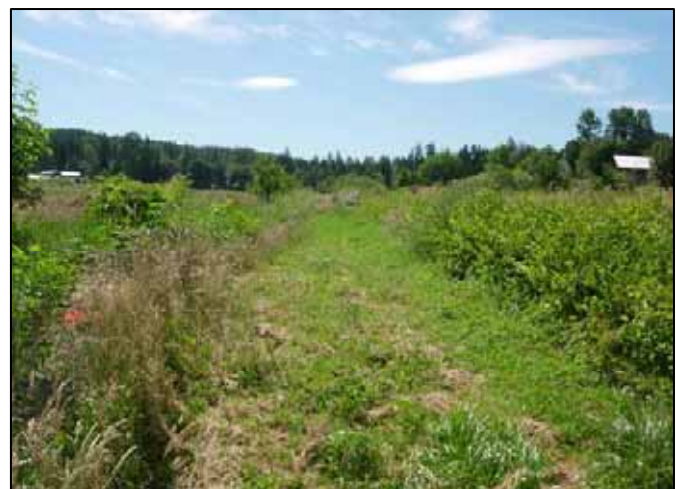
Photo-point 8 faces upstream from the northernmost (furthest downstream) end of the site.

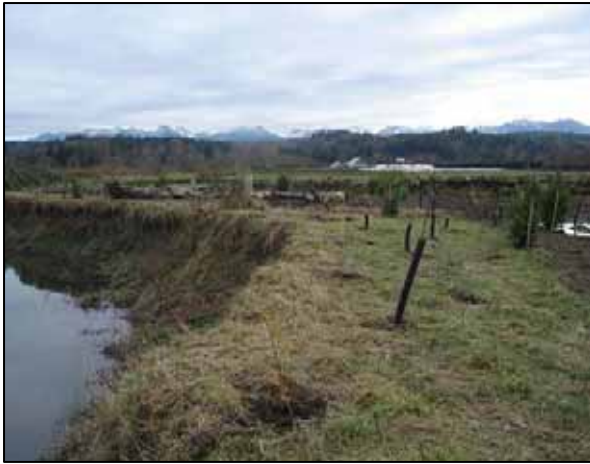
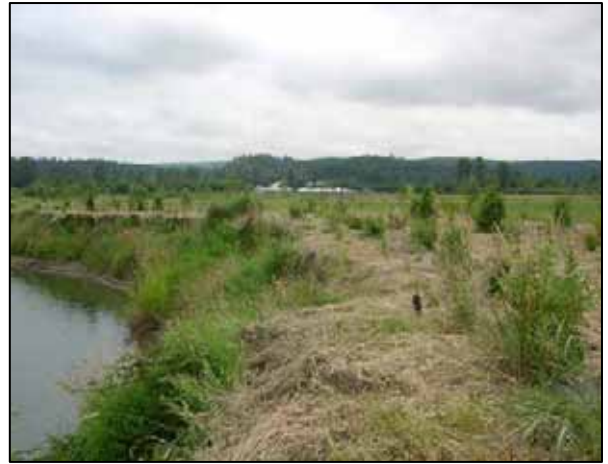
Photo-point 2 shows the planting area and staked bank.

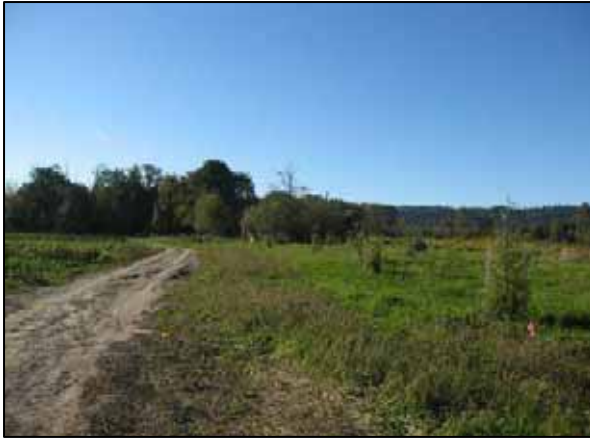
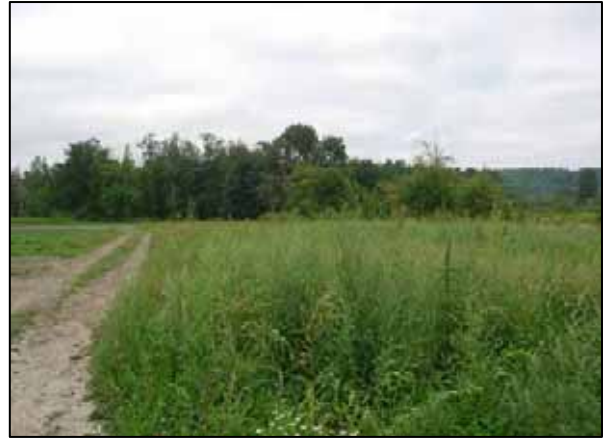
Photo-point 3 shows the planting area facing west.

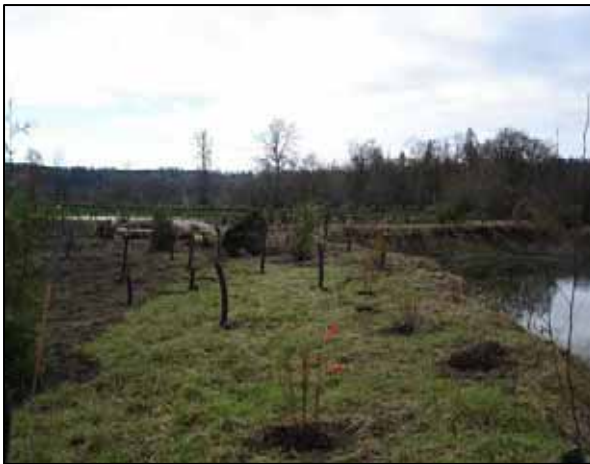
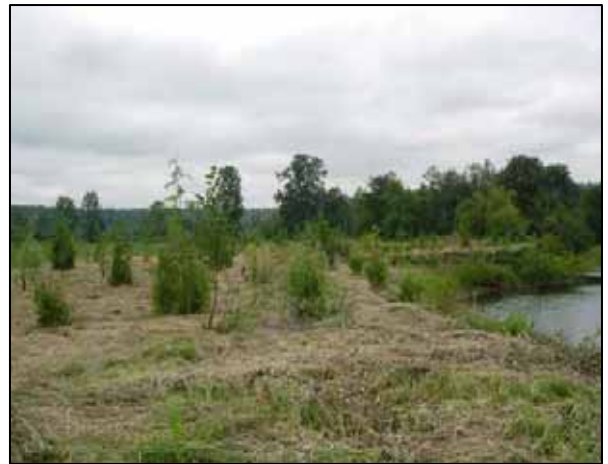
Photo-point 4 faces southwest down the planting

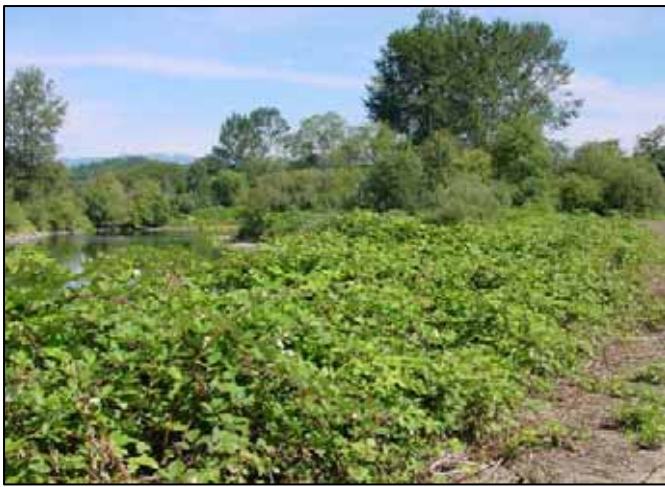
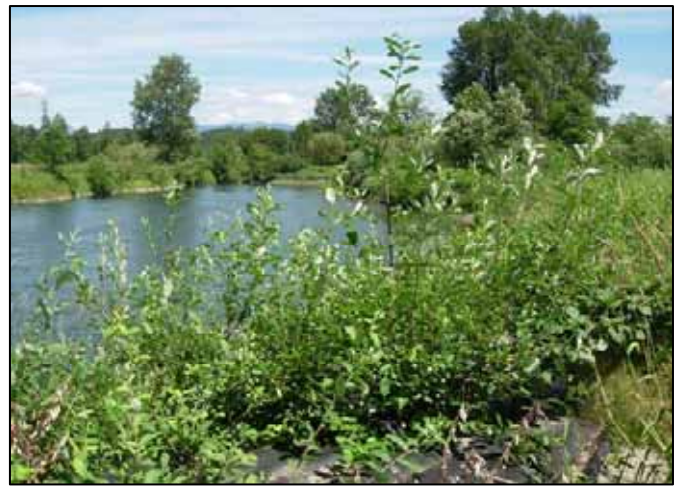
Photo-point 1 shows the buffer facing upstream.

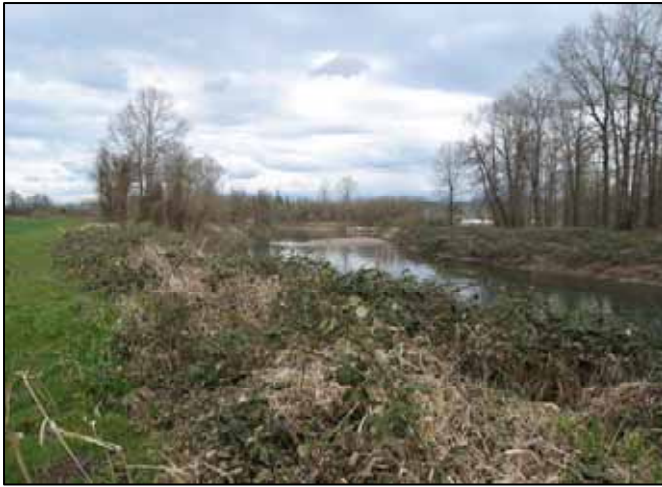
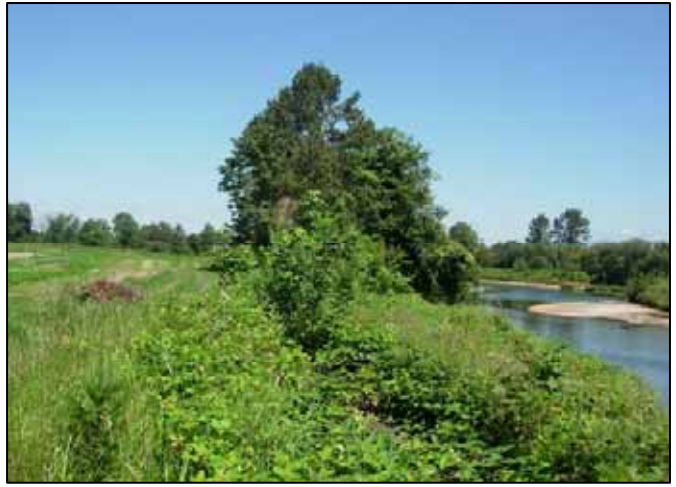
Photo-point 6 shows the buffer from the furthest point upstream, facing downstream.

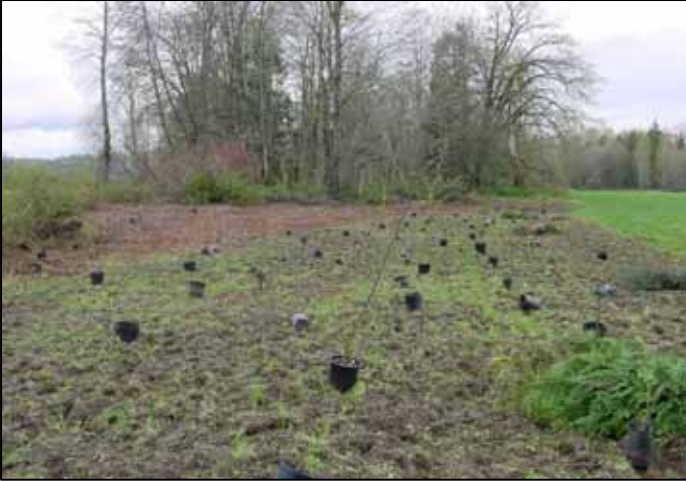
Photo-point 5 is taken from within the planted area.
